CHIMNEY - FIREPLACE INSPECTION

02/11/2026

SUMMARY

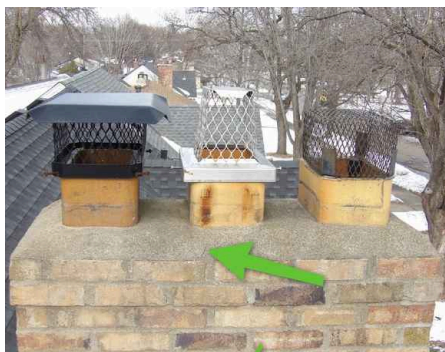
Photos Exterior: Close up of Crown and Caps

Chimney Exterior and Roof View
Comments: General Condition of the exterior of the chimney
Fair

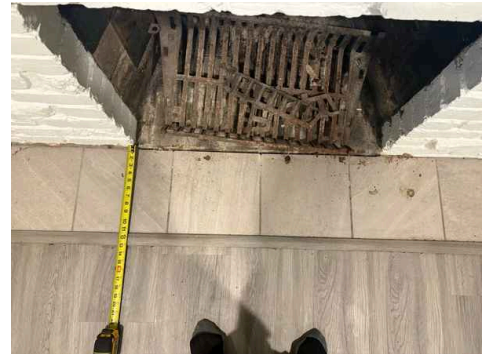
3.6.1 Hearth Deficiencies

Safety Hazard

Recommended extension is 16" in front and 8" on each side for openings less than 864 square inches.

Recommended extension is 20" in front and 12" on each side for openings greater than 864 square inches.

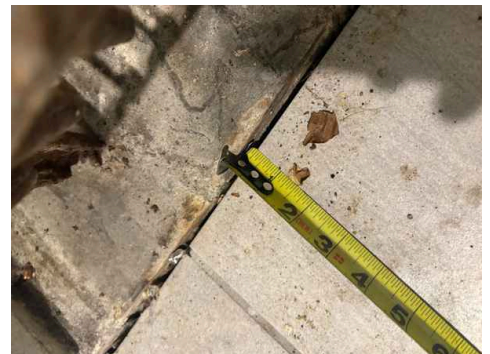
3.6.2 Hearth Deficiencies

Maintenance or Review Item

CRACKS AND/OR GAPS IN MORTAR BETWEEN HEARTH EXTENSION AND THE HEARTH

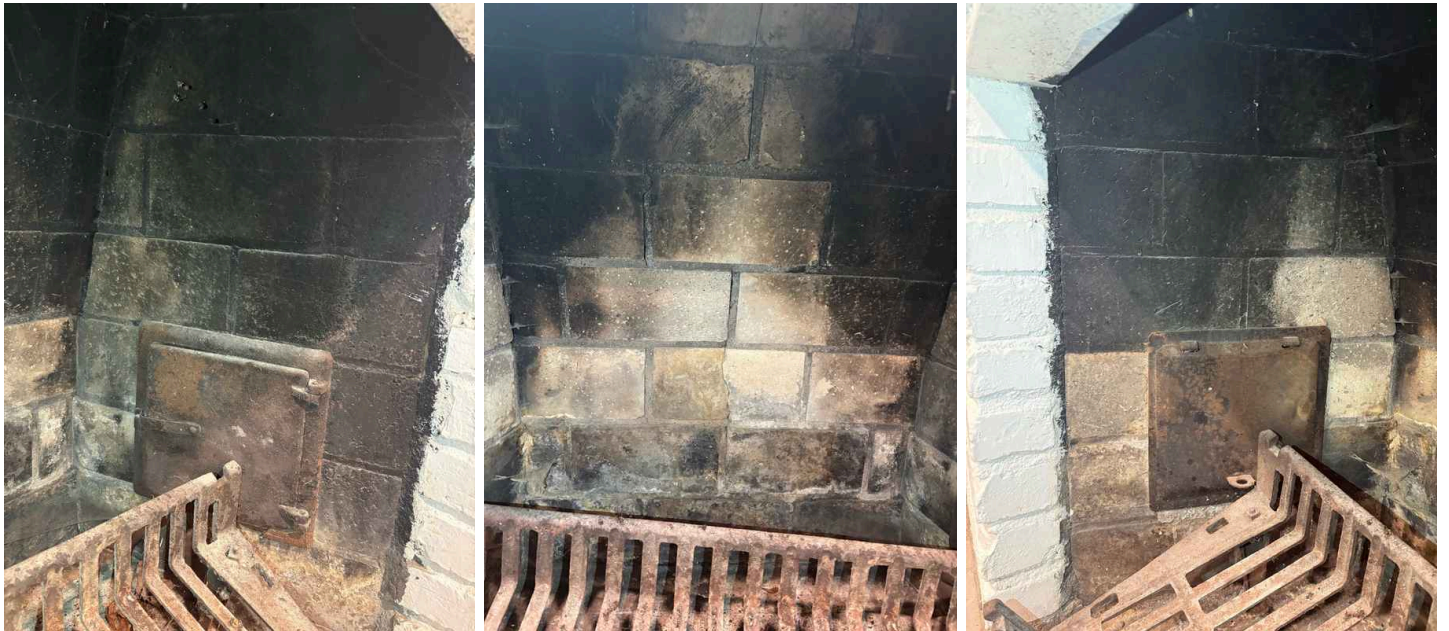
3.7.1 Combustion Chamber/Firebox Deficiencies

COMBUSTION EXTERIOR AIR INTAKE IS NOT INSTALLED

A combustion air inlet must be present, clean and/or clear of debris for proper draw or to prevent excessive amount of conditioned air from being drawn out of the home cause excessive intake of exterior air to be pulled into the home.

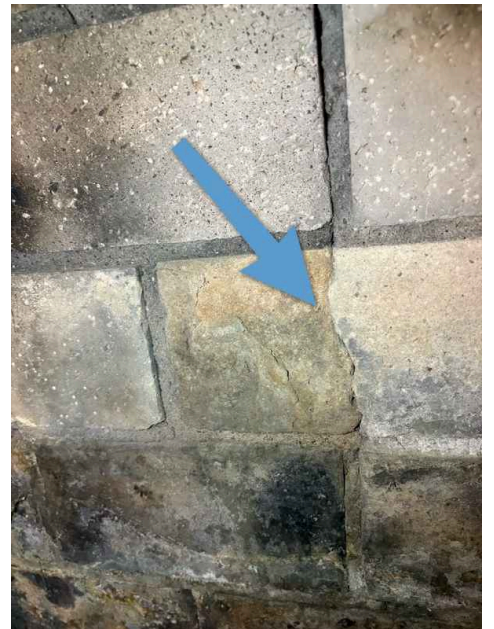
3.7.2 Combustion Chamber/Firebox
Deficiencies

FIREBRICK IN FIREBOX IS DETERIORATED, CRACKED OR BROKEN

Fireplace firebrick components must be maintain in good condition for safe operation. Damaged or deteriorated components compromises the safety of the fireplace.

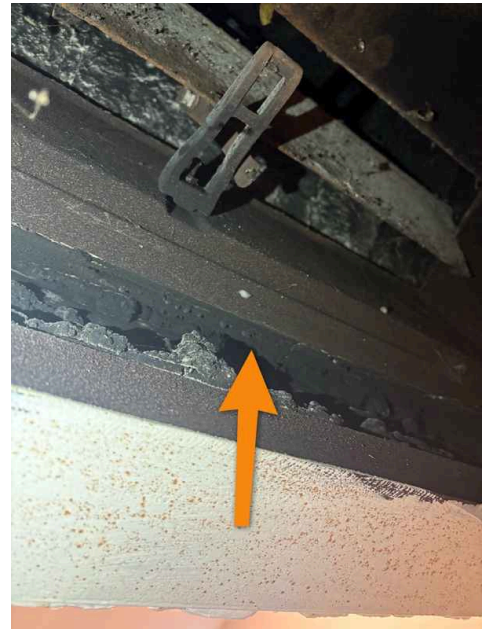
3.7.3 Combustion Chamber/Firebox
Deficiencies

Recommended Action - More Significant Cost

NFPA 211 States:

11.2.1.5 All joints and intersections between the hearth extension/fireplace facing and the fire chamber (firebox) shall be fully sealed with medium-duty refractory mortar (ASTM C199, Standard Test Method for Pier Test for Refractory Mortars). Gaps or voids at supporting lintels and joints between steel fireplace units and the fireplace face or between the frames of dampers and the fireplace face shall be sealed with the same material or with a high-temperature [2000°F (1093°C) service rating] insulating mortar.

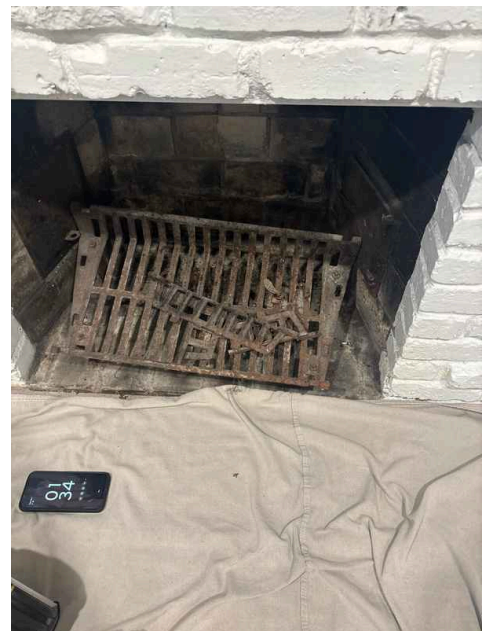
3.7.4 Combustion Chamber/Firebox
Deficiencies

Maintenance or Review Item

GRATE IS DAMAGED OR DETERIORATED

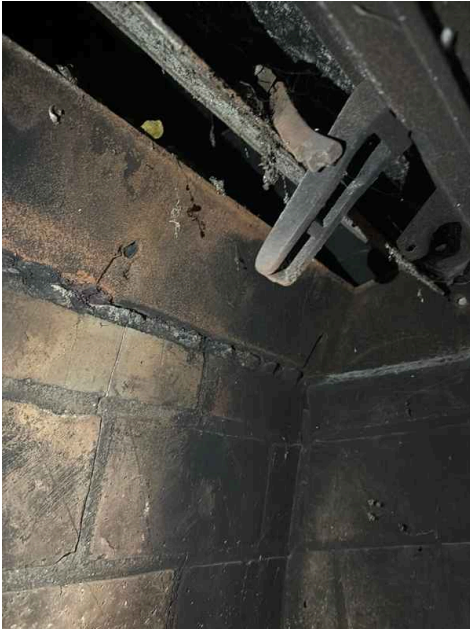
3.8.1 Damper
Deficiencies

Recommended Action - More Significant Cost

DAMPER IS DAMAGED, OR DETERIORATED AND DOES NOT CLOSE OFF AIR FLOW OR OPEN FULLY

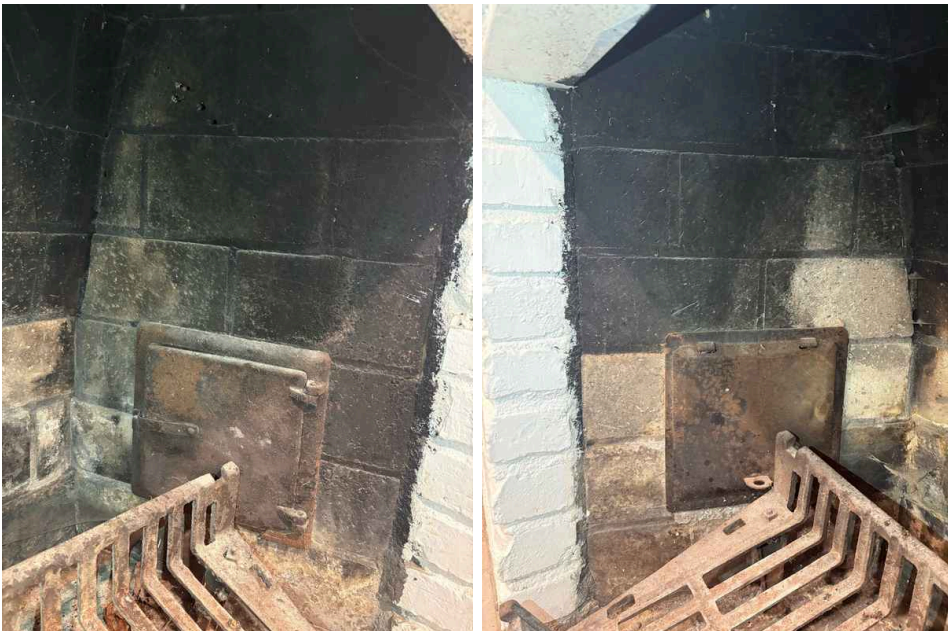
3.9.1 Ash Dump

ASH DUMP CLEANOUT DOOR IS LOCATED IN THE FIREBOX OF THE LOWER LEVEL FIREPLACE.

Safety Hazard

Ash pit clean-out door for the upper level fireplace is located in the firebox of the lower level fireplace.

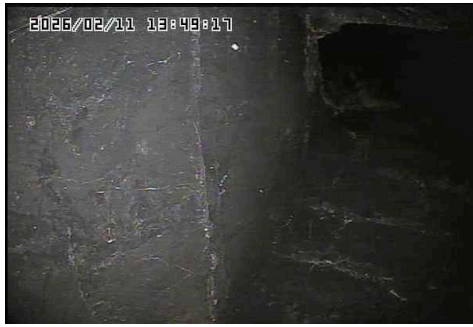
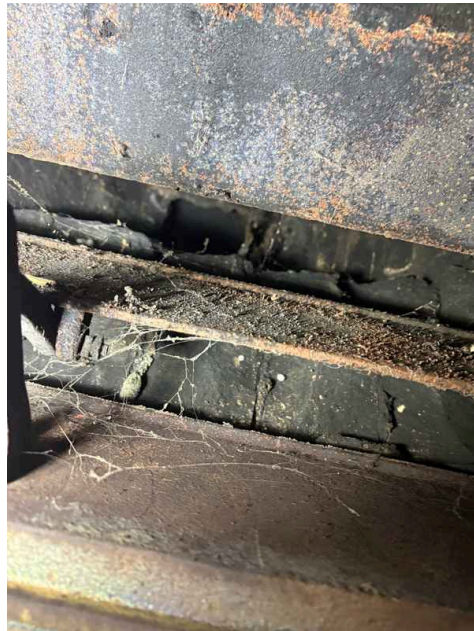
3.10.1 Smoke Chamber Deficiencies

SMOKE CHAMBER BRICK ARE NOT PARGED SMOOTH

Recommended Action - More Significant Cost

NFPA 11.2.1.13 States: The inner surfaces of the smoke chamber shall be parge coated smooth, with an insulating refractory mortar, and not inclined more than 45 degrees from vertical.

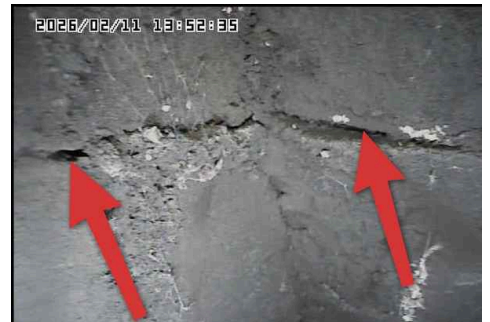
3.10.2 Smoke Chamber Deficiencies

VOIDS OR GAPS OBSERVED IN THE SMOKE CHAMBER

Safety Hazard

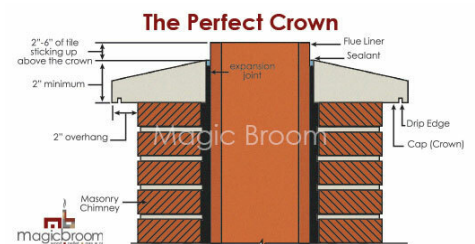
3.11.1 Crown & Caps Deficiencies

CHIMNEY CROWN (AKA CAP OR WASH) LACKS A PROPER DRIP EDGE

A proper drip edge is required to help prevent water from penetrating the brick, stone or wood chimney. The drip edge is not present Water penetration increases the potential for deterioration of the brick and other chimney components at the interior and exterior of the chimney. Damage may include: disintegration, cracks, and spalling.

R1003.9.1 Chimney caps. Masonry chimneys shall have a concrete, metal or stone cap, a drip edge and a caulked bond break around any flue liners in accordance with ASTM C1283. The concrete, metal or stone cap shall be sloped to shed water.

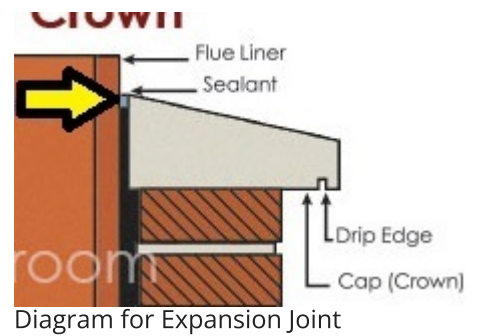
3.11.2 Crown & Caps Deficiencies

Recommended Action - More Significant Cost

CROWN LACKS EXPANSION JOINT BETWEEN CROWN AND THE FLUE LINER

The required expansion joint to allow for movement between the flue liner and crown is not present. A properly seal expansion joint allows for the flue liner to move yet keep a water tight seal to prevent water infiltration. Lack of an expansion joint has the potential to cause cracks at the crown and the flue liner.

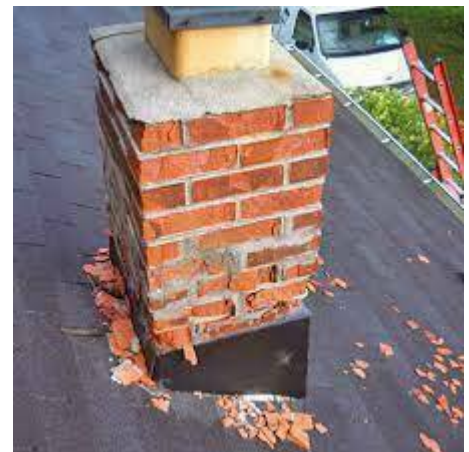
3.11.3 Crown & Caps Deficiencies

Maintenance or Review Item

CROWN HAS MINOR HAIRLINE CRACKS (CROWN AKA: CAP OR WASH)

The crown is designed to keep water out of the chimney and shed the water away so it does no run down the chimney exterior. Water penetrating the crown has the potential to cause premature deterioration and spalling of the brick.

Example of damage from water

Seal cracks to reduce the potential for water intrusion.

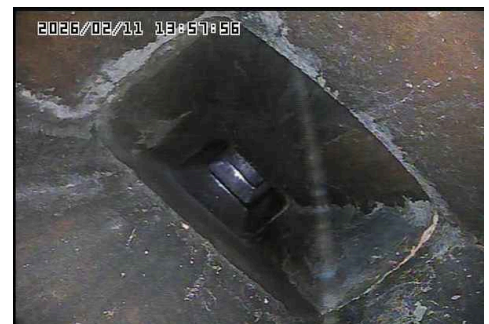
3.12.1 Flue Liner Deficiencies

Recommended Action - More Significant Cost

Recommended flue cross sectional area **87**
 Actual flue **77**

Square chimney flues or rectangular or oval flues with an aspect ration of less than 2 to 1 ratio shall have a minimum net cross-sectional area of at least One-tenth the fireplace opening

Rectangular or oval chimney flues with an aspect ratio greater than 2 to 1, shall have a minimum net cross-sectional area of at least one-eighth the fireplace opening.

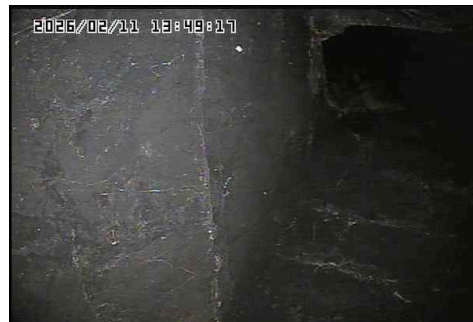
3.12.2 Flue Liner Deficiencies

Safety Hazard

NFPA 211 States:

7.1.2.6 Corbeled or solid masonry shall be provided in masonry chimneys to support the entire perimeter of flue liners.

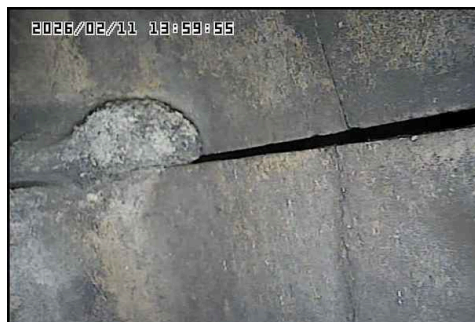
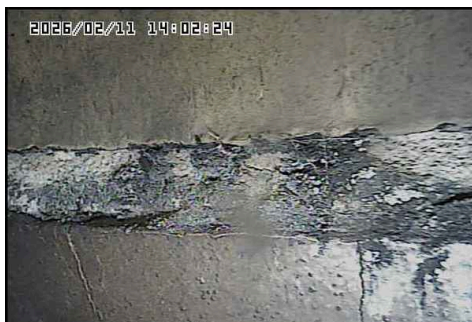
3.12.3 Flue Liner Deficiencies

HAIRLINE OR SMALL GAPS AND CRACKS IN THE JOINTS BETWEEN THE FLUE LINER SECTIONS

Missing or cracked/deteriorated mortar in the joints of the clay flue liner. Without mortar in these joints, hot gases could enter between the clay sections and lead to a chimney fire. Have the chimney repaired by a CSIA Certified Chimney Sweep before using the fireplace.

The 2019 NFPA, Chapter 14.9 states: "If the flue liner in a chimney has softened, cracked, or otherwise deteriorated so that it no longer has the continued ability to contain the products of combustion (i.e., heat, moisture, creosote, and flue gases), the liner shall be either removed and replaced, repaired, or relined with a listed liner system or other approved material that will resist corrosion, softening, or cracking from flue gases at temperatures appropriate to the class of chimney service."

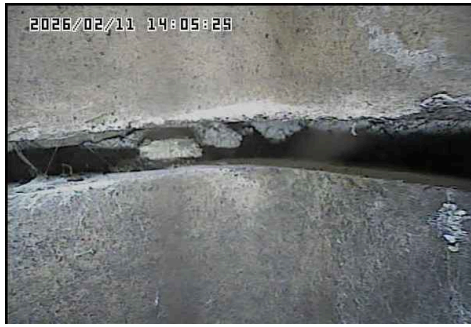
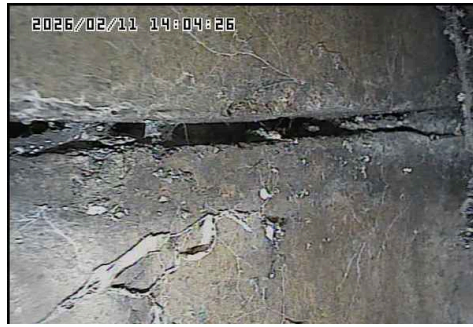
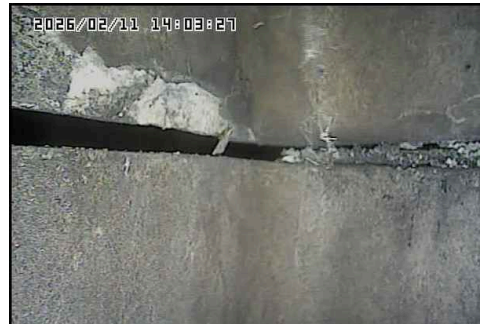
3.12.4 Flue Liner Deficiencies

SIGNIFICANT CRACKS AND/OR GAPS IN THE JOINTS OF THE CLAY FLUE LINER

Recommended Action - More Significant Cost

Cracks in the joints of the clay flue liner. Even small gaps in these joints can allow hot gases enter between the clay sections and lead to a chimney fire. Have the chimney repaired by a CSIA Certified Chimney Sweep before using the fireplace.

The 2019 NFPA, Chapter 14.9 states: "If the flue liner in a chimney has softened, cracked, or otherwise deteriorated so that it no longer has the continued ability to contain the products of combustion (i.e., heat, moisture, creosote, and flue gases), the liner shall be either removed and replaced, repaired, or relined with a listed liner system or other approved material that will resist corrosion, softening, or cracking from flue gases at temperatures appropriate to the class of chimney service."

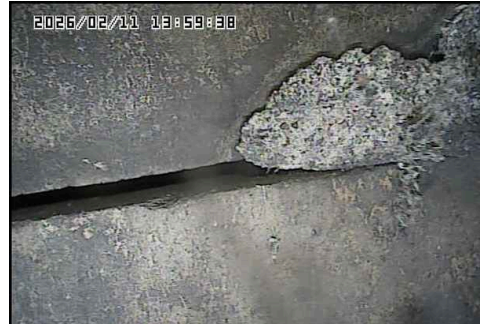
3.12.5 Flue Liner Deficiencies

FLUE LINER JOINTS ARE NOT SMOOTH

Safety Hazard

The mortar in the flue liner joints are to be smooth to reduce turbulence, improve flow and reduce the accumulation of creosote. The joint(s) have rough, excessive or protruding mortar.

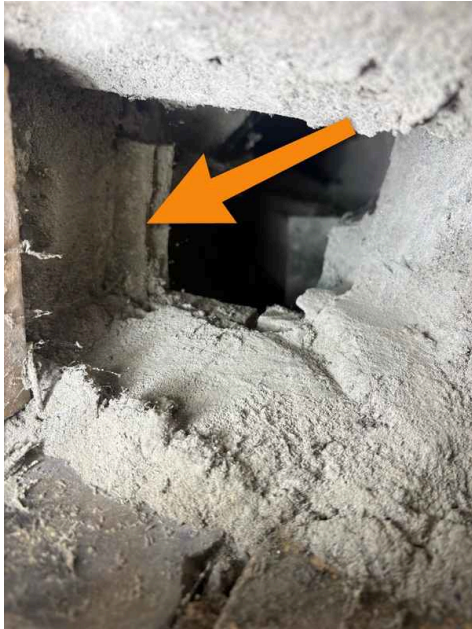
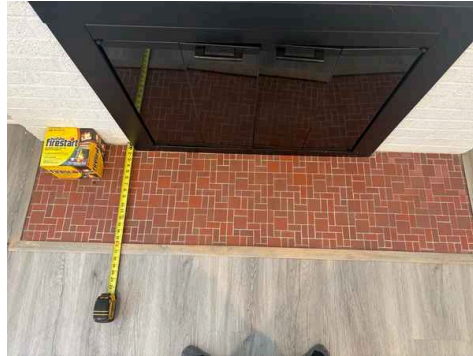
4.4.2 Hearth Deficiencies

11.3.1.1 Support for the hearth shall be provided by a structural slab or corbeled brickwork.

11.3.1.2 Wooden forms used during the construction of the hearth and hearth extension shall be removed when the construction is completed

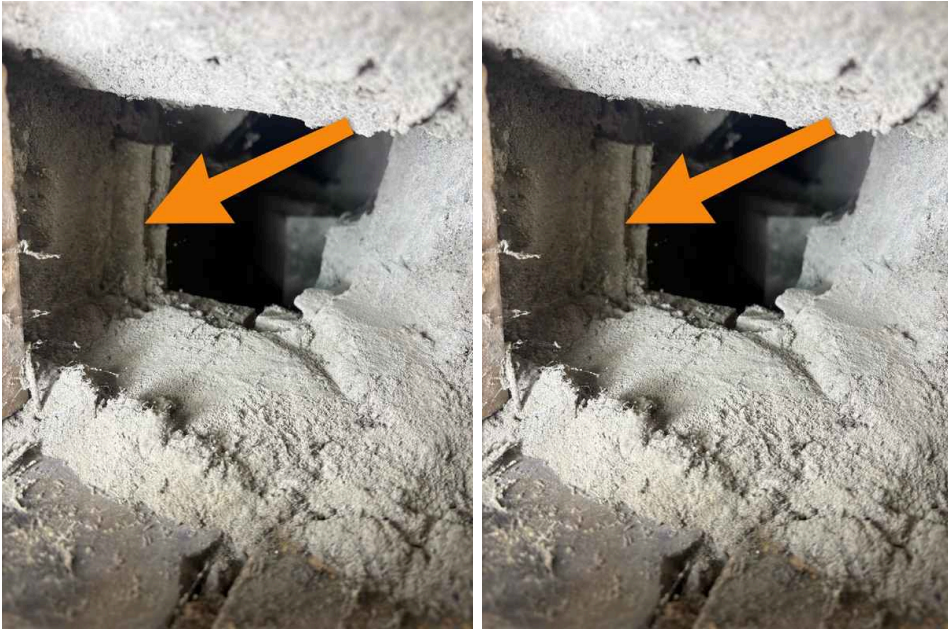
4.4.3 Hearth Deficiencies

NFPA 211 States

11.3.1.2 Wooden forms used during the construction of the hearth and hearth extension shall be removed when the construction is completed

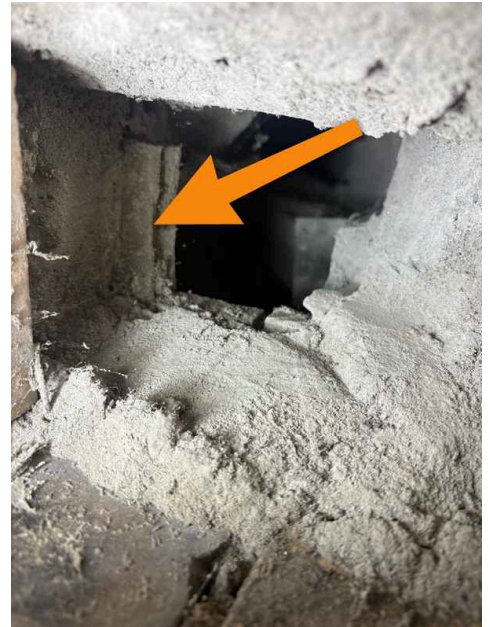
4.7.1 Ash Dump

ASH DUMP - COMBUSTIBLE MATERIALS IN THE ASH DUMP

Safety Hazard

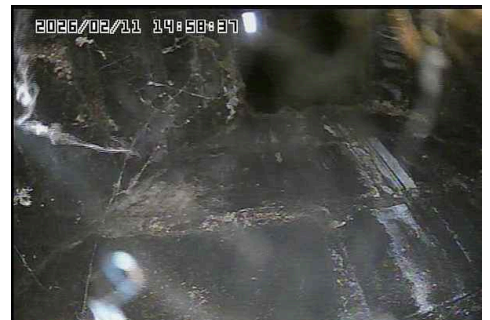
4.8.1 Smoke Chamber Deficiencies

SMOKE CHAMBER BRICK ARE NOT PARGED SMOOTH

NFPA 11.2.1.13 States: The inner surfaces of the smoke chamber shall be parged smooth, with an insulating refractory mortar, and not inclined more than 45 degrees from vertical.

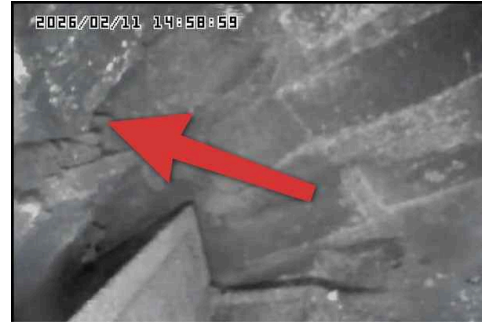
4.8.2 Smoke Chamber Deficiencies

VOIDS OR GAPS OBSERVED IN THE SMOKE CHAMBER

The smoke chamber must be completely free of voids, gaps openings. It also must be sealed at the flue liner and the damper assembly

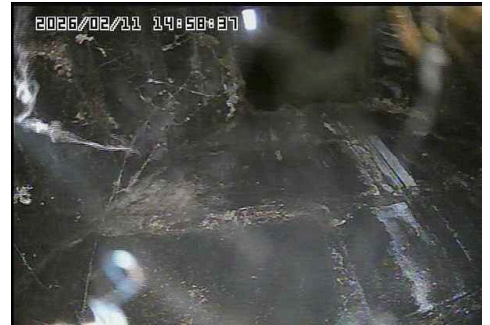
4.10.1 Flue Liner Deficiencies

Square chimney flues or rectangular or oval flues with an aspect ration of less than 2 to 1 ratio shall have a minimum net cross-sectional area of at least One-tenth the fireplace opening

Rectangular or oval chimney flues with an aspect ratio greater than 2 to 1, shall have a minimum net cross-sectional area of at least one-eighth the fireplace opening.

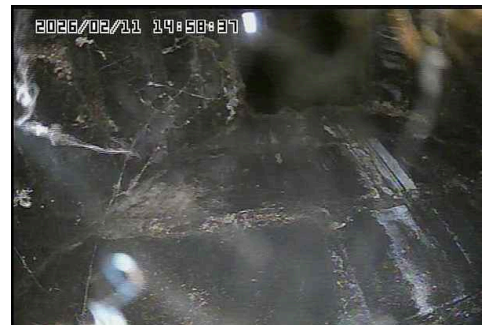
4.10.2 Flue Liner Deficiencies

NFPA 211 States:

7.1.2.6 Corbeled or solid masonry shall be provided in masonry chimneys to support the entire perimeter of flue liners.

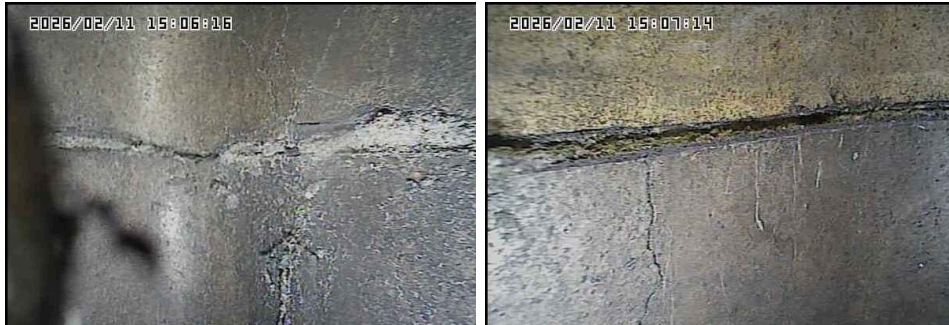
4.10.3 Flue Liner Deficiencies

Missing or cracked/deteriorated mortar in the joints of the clay flue liner. Without mortar in these joints, hot gases could enter between the clay sections and lead to a chimney fire. Have the chimney repaired by a CSIA Certified Chimney Sweep before using the fireplace.

The 2019 NFPA, Chapter 14.9 states: "If the flue liner in a chimney has softened, cracked, or otherwise deteriorated so that it no longer has the continued ability to contain the products of combustion (i.e., heat, moisture, creosote, and flue gases), the liner shall be either removed and replaced, repaired, or relined with a listed liner system or other approved material that will resist corrosion, softening, or cracking from flue gases at temperatures appropriate to the class of chimney service."

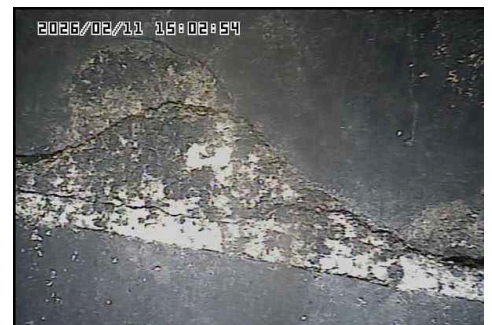
4.10.4 Flue Liner Deficiencies

FLUE LINER JOINTS ARE NOT SMOOTH

Safety Hazard

The mortar in the flue liner joints are to be smooth to reduce turbulence, improve flow and reduce the accumulation of creosote. The joint(s) have rough, excessive or protruding mortar.
